COAL BURNER REGISTER, NOZZLES AND LIGHTERS INSPECTION

OBSERVATIONS AND WORK ACCOMPLISHED

To	C. A. PALMBERG - PM PROJECT MANAGEMENT - BVCB3K	
From	W. E. NEWKIRK - COMBUSTION SYSTEMS - BVN01C	
Cust.	INTERMOUNTAIN POWER	File No. or Ref. RB-614
Subj.	BURNER INSPECTION	Date MAY 22, 1987

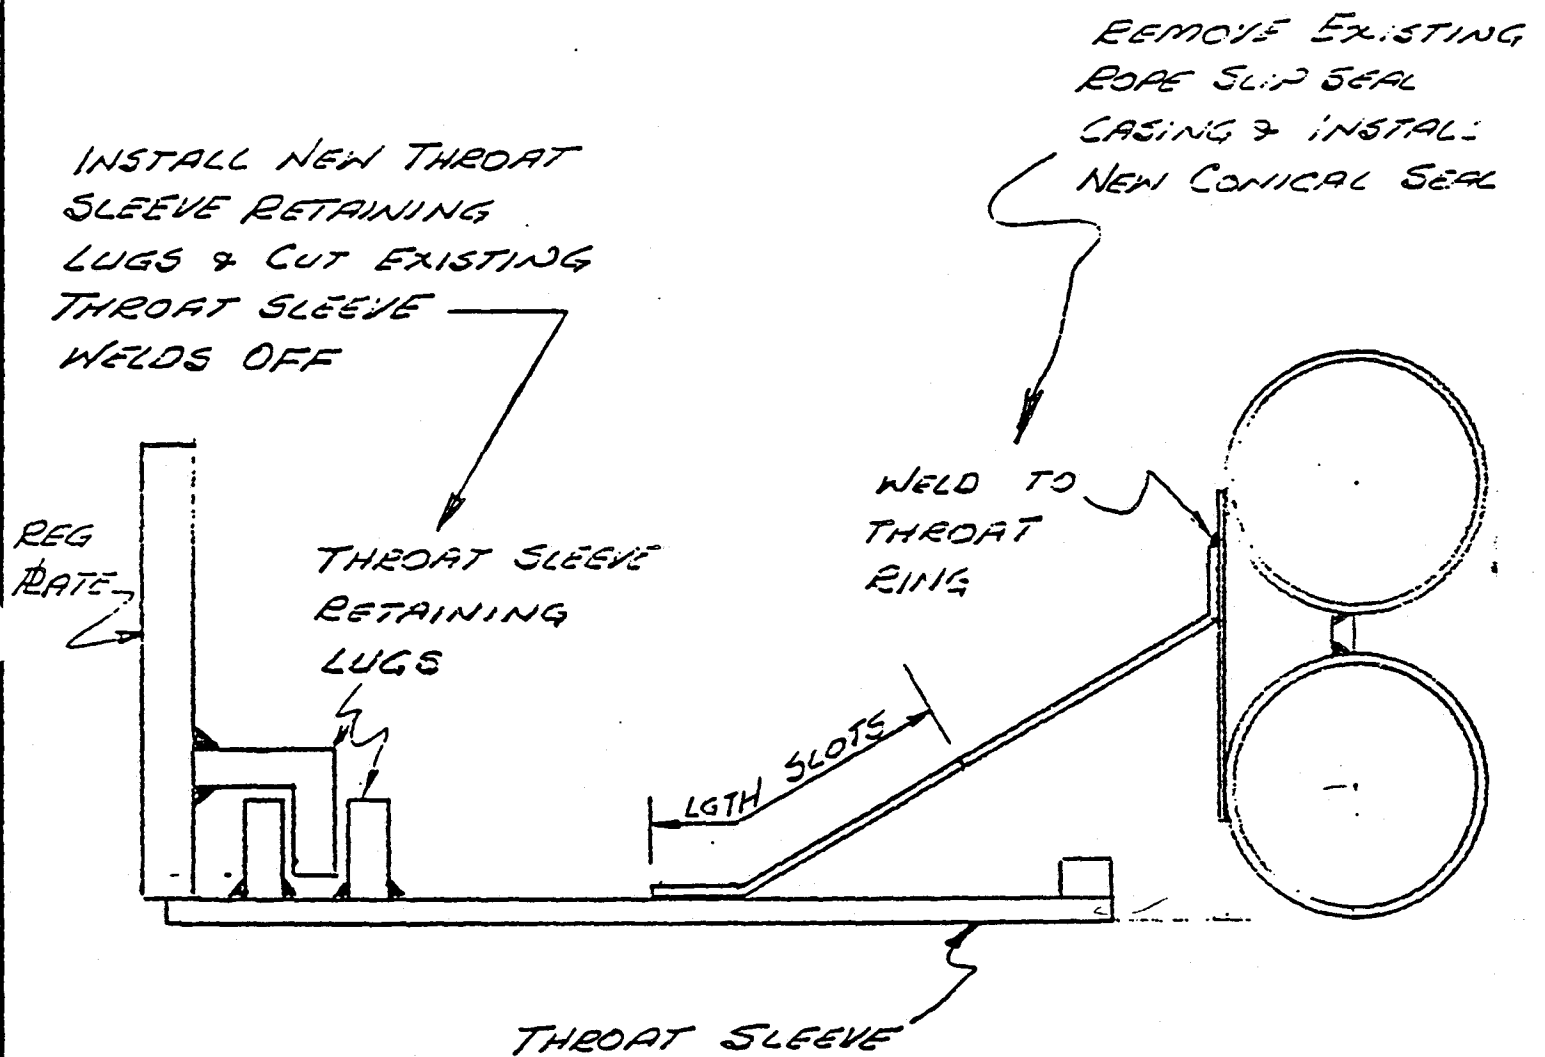
SUBJECT THROAT SLEEVE ATTACHMENTS 8

1. Most of the burners have failed welds attaching throat sleeve to the register plate.
2. The throat sleeve on many burners are barrel shaped. This will not effect the functional operation of the burner.
3. Corrective repair for attachment must be made. See attached sketch.

INSTALL SLIDING
SLEEVE AROUND REG.

WELD 1" DIA
GUIDE PIPE
TO REG. R.

MAX TRAVEL 10"

CUT ALL WELDS &
STIFFENER BARS
FREE OF REG R

WELD RETAINING
LUGS EACH
SIDE OF
REG R

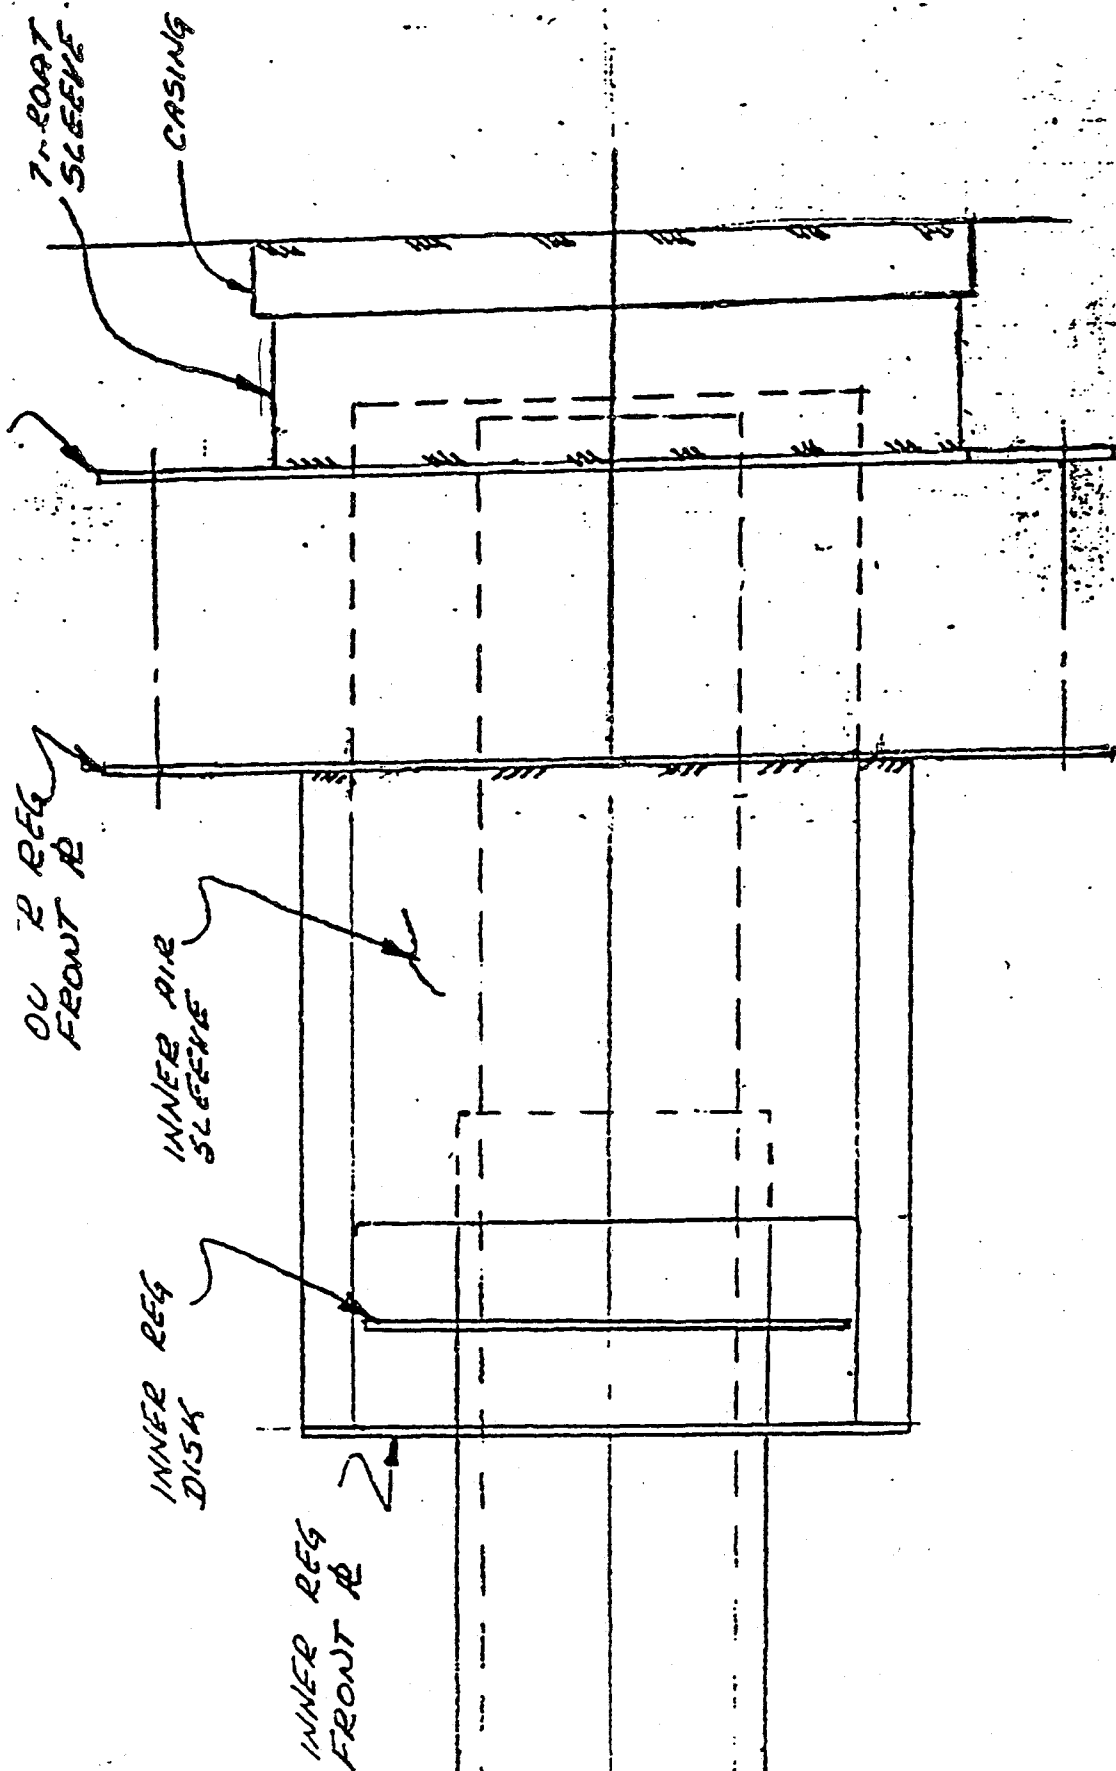
CUSTOMER INTERMOUNTAIN POWER
SUBJECT AIR REGISTER MODIFICATION

1. The register plates do not indicate further warping of the plates and are functionally sound. Although they are distorted, resulting in poor alignment of door shafts making linkage adjustment and door adjustment almost impossible. However, registers are still functional.
2. Should it be a requirement to adjust registers on line, A device to regulate the amount of air flow to the burner can be designed to enable outer register air flow adjustment. The air doors will then be set for swirl and no further adjustment to the existing doors.
3. Welds attaching outer register to inner air sleeve will be cut free and register position will be maintained by lugs attached to inner air sleeve. This method of attachment will allow differential expansion between air sleeve and register plate. See attached sketch.

CONTROL RODS (2)

SET REG DOORS
FOR SWING &
LOCK IN PLACE

SLEEVE SHOWN IN CLOSED POSITION
